3.4.4. Shingle restoration

3.4.4.1 Technical considerations

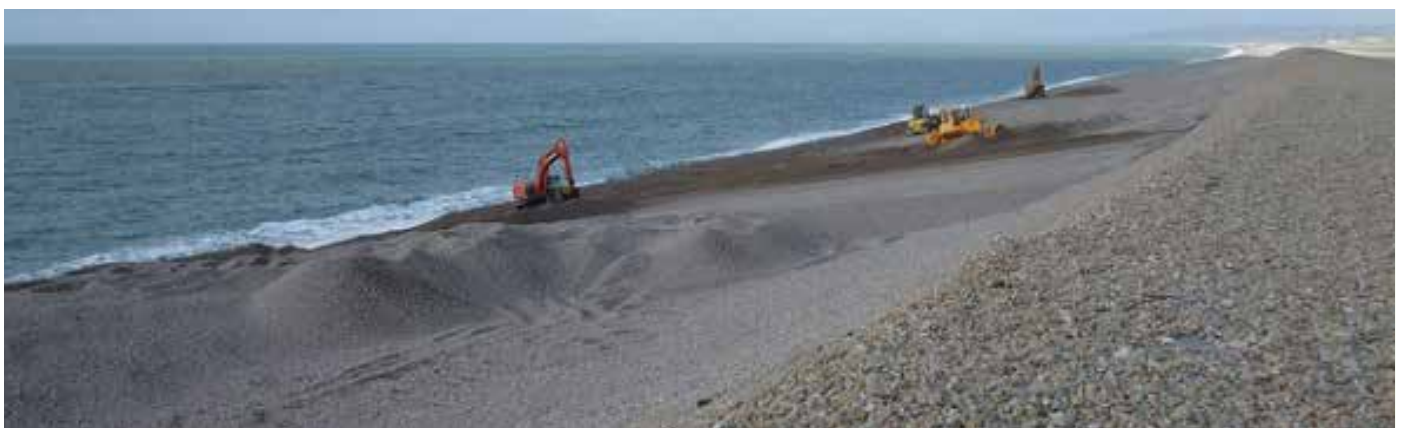
Figure 3.18. Replenishment and reprofiling on the shingle at Chesil beach, Dorset: This work was undertaken in order to increase protection to the community of Chiswell following significant storms (© Environment Agency).

Re-profiling (Figures 3.18 and 3.19) is appropriate where previous management practices have created a very high, narrow shingle ridge for flood protection or where a recharge scheme is being undertaken and it has not been deemed appropriate to allow the shingle ridge to form naturally. In some cases, it may also be undertaken to repair a breach following a storm. However, care should be taken that re-profiling does not reduce the availability of sediment downdrift, potentially increasing flood or erosion risk there. In more stable beaches it can be more damaging to try to repair a shingle breach due to the impacts on vegetation

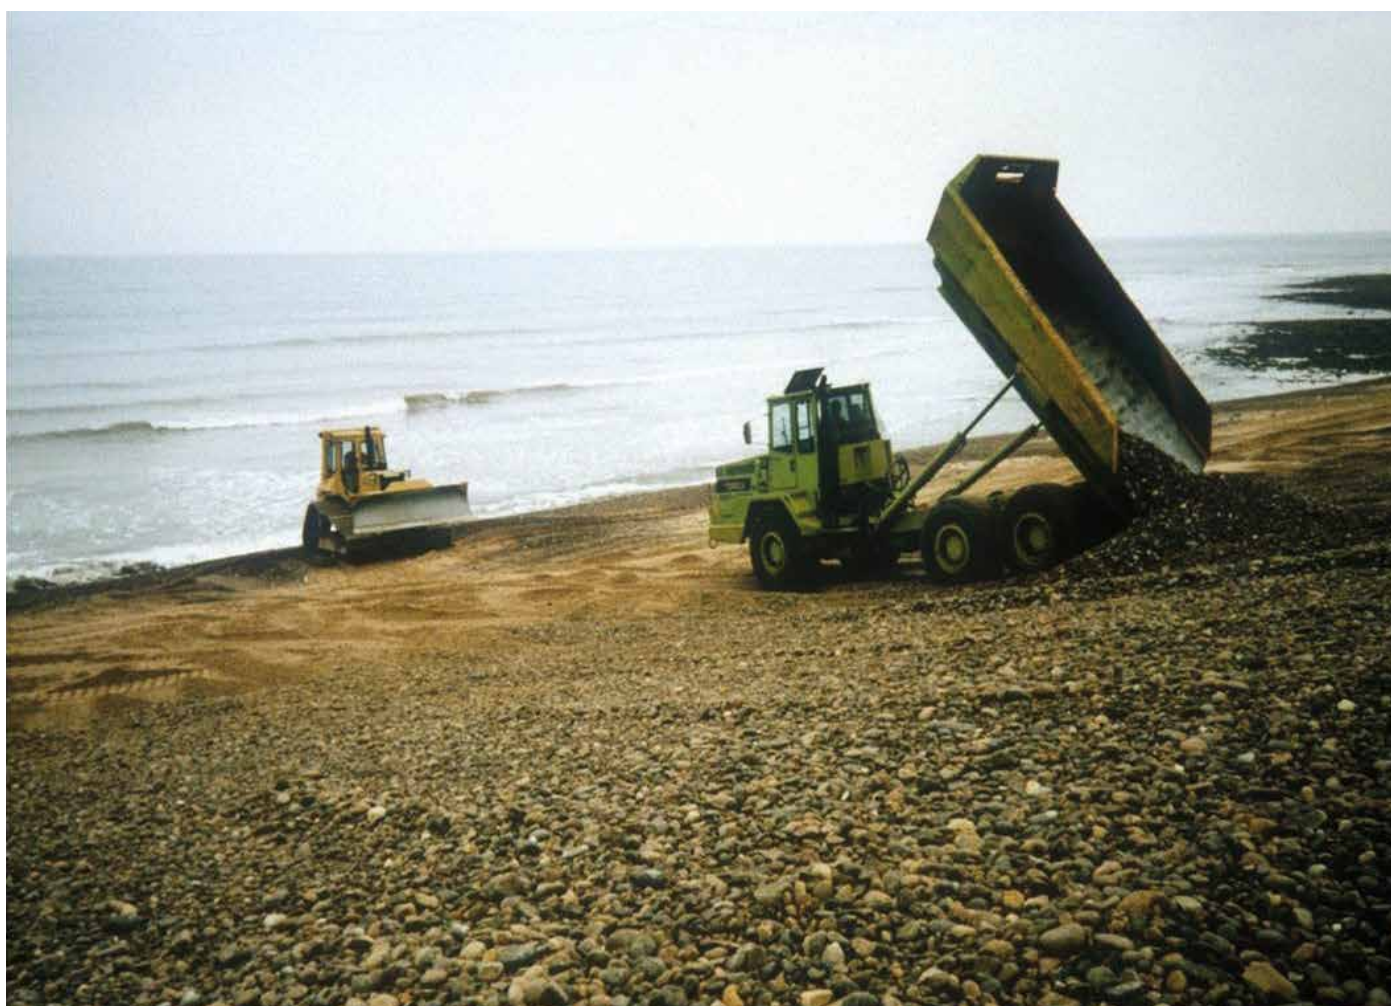
Figure 3.19. Shingle restoration at Spey Bay, Moray – Scotland's largest shingle beach (© Sally Gemell).
